ESTABLISHMENT OF ENGINEERING DESIGN DATA FOR
HYBRID STEEL/CERAMIC BALL BEARINGS

Phase II

Final Report on Contract Number N00019-79-C-0418

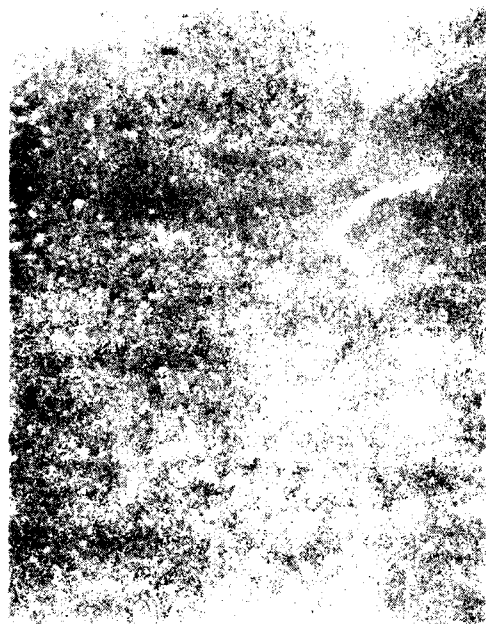
Figure 5. Photomicrographs of Silica (1000X) and
 and texture (1000X).

Using samples taken from each billet, fracture surfaces were analyzed by scanning electron microscopy and polished sections were analyzed optically by Nomarskii interference contrast. Figure 5 shows typical SEM micrographs of fracture surfaces and optical micrographs of the silicon nitride microstructure. HPSN fracture surfaces were analyzed using the scanning electron microscope in the secondary electron and back-scattered electron imaging modes. Fracture surfaces from billet to billet were for all practical purposes identical. Both intergranular and transgranular fracture were observed which is typical of HPSN. Microscopic analysis of the polished sections was unable to distinguish differences in inclusion content from billet to billet. However, low power and visual observations had revealed slight differences in the material's polishing behavior. In the extreme, variations of this nature could produce differences in the surface characteristics of the finished parts. However, the differences noted in this instance were not thought to be significant.

A. Typical photomicrographs. Normalized interference contrast.
 Black = voids, gray = pullout, gray = chert, white = chert
 chert = chert, gray = chert, white = chert

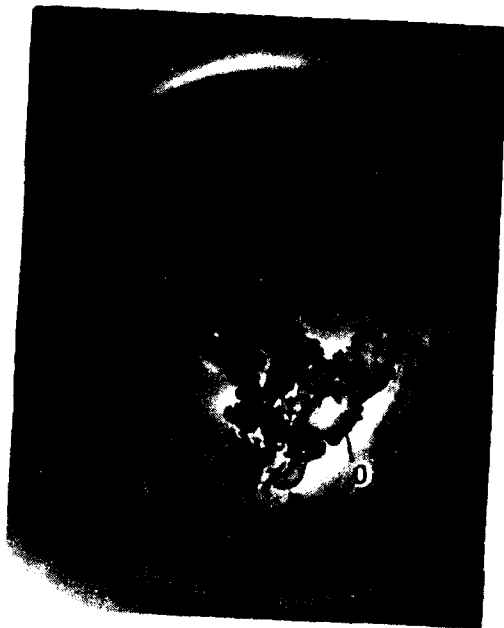
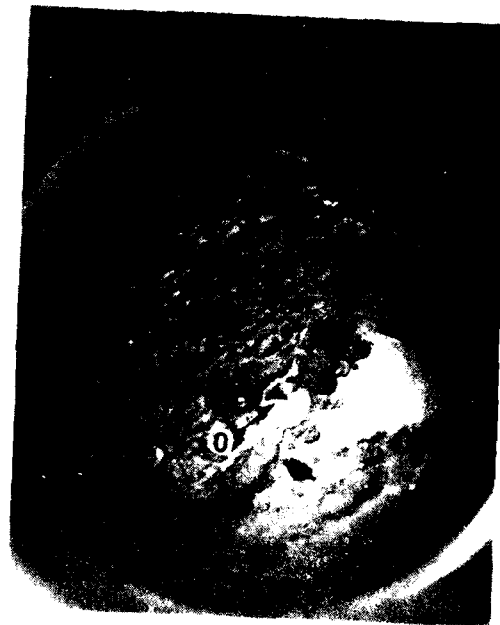
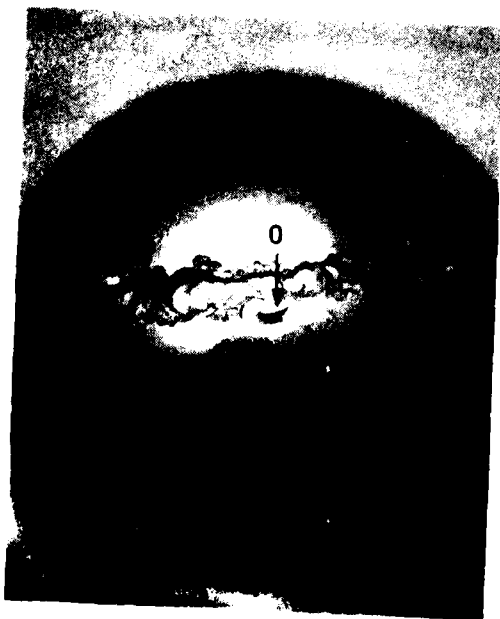
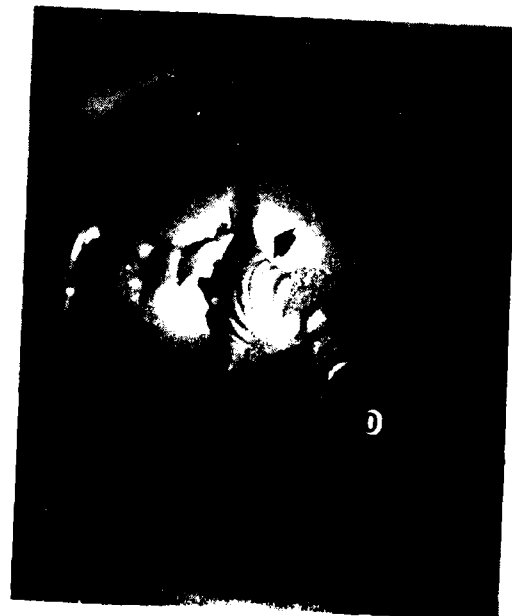
Figure 10. Typical Spall Patterns in Tested
Silicon Nitride Ball
Indicates Spall Origin and Approximate
Spall Propagation Direction

Optical analysis of the spalled silicon nitride ball was the first step in failure analysis. Fracture origins and crack propagation directions were readily observed during optical inspection. Figure 10 shows typical silicon nitride ball spalls. Note that the general surface appearance was similar among balls tested at two different thrust loads; ball 618-050 at 5.0 kN (1125 lbf); and balls 610-054, 610-056, and 610-057 at 9.56 kN (2150 lbf). After locating fracture origins, selected balls were observed by the scanning electron microscope.

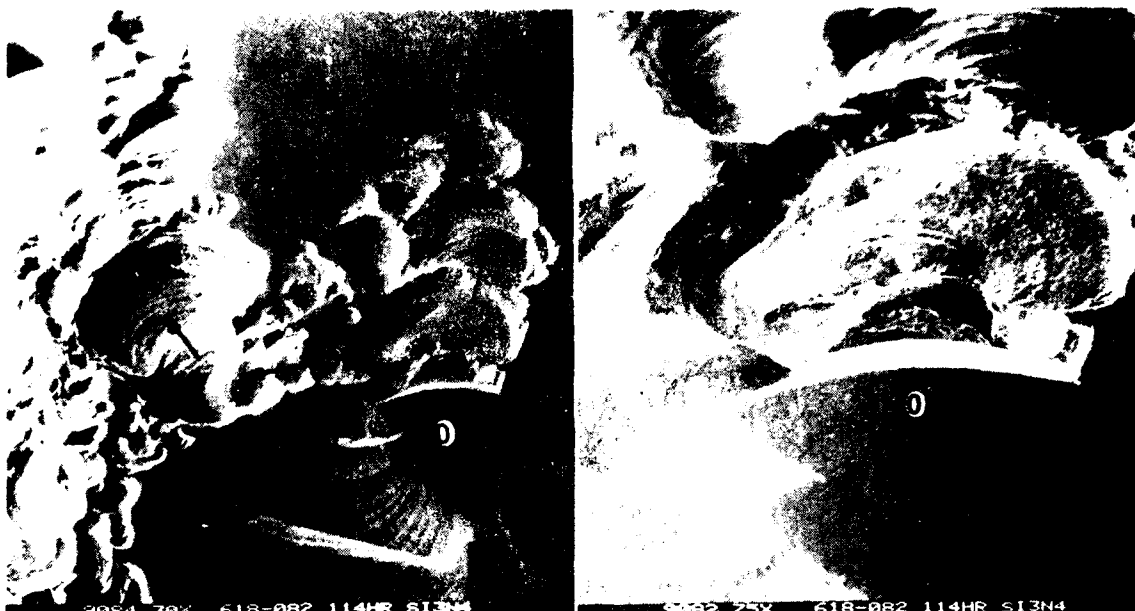
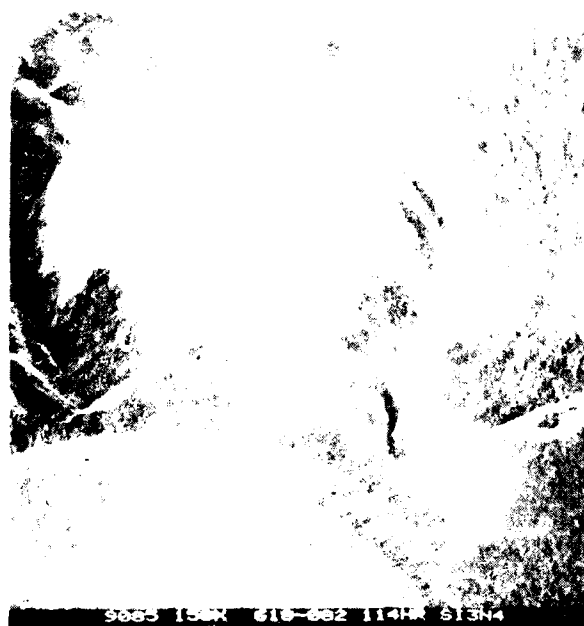
Figure 11. (Left) ... Direction
 ... No. 82

Figures 11 and 12 contain scanning electron photomicrographs at various magnifications of spall initiation areas on two balls tested at the high load. Figure 13 is a composite sequence of photomicrographs documenting fracture initiation and presumed spall progression from a series of balls also tested at the high load. Figure 13A shows a typical cone crack which is thought to be the failure initiation point. Figures 13B, 13C and 13D show the progression of this crack into extensively spalled areas in the direction of the maximum stress. Figure 13D also illustrates

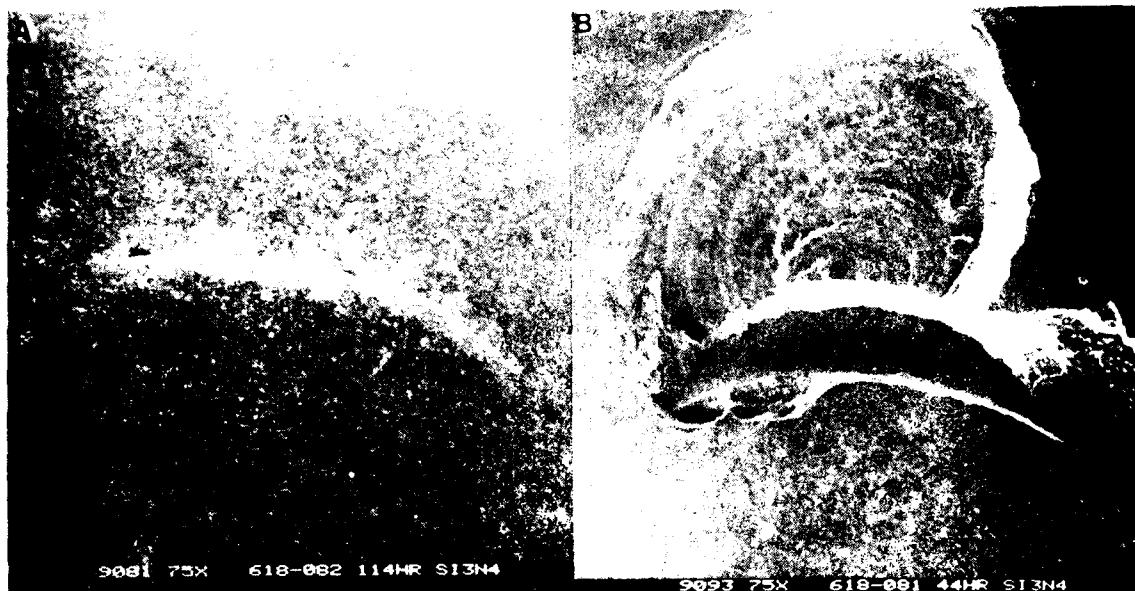
spall propagation on the concave side of the original crack. This progression results from the continued impact at the discontinuity in the silicon nitride surface. A small semicircular crack can be seen at the edge of the spalled area in Figure 13C. Continued running would have resulted in the growth of a spalled region at this juncture also.

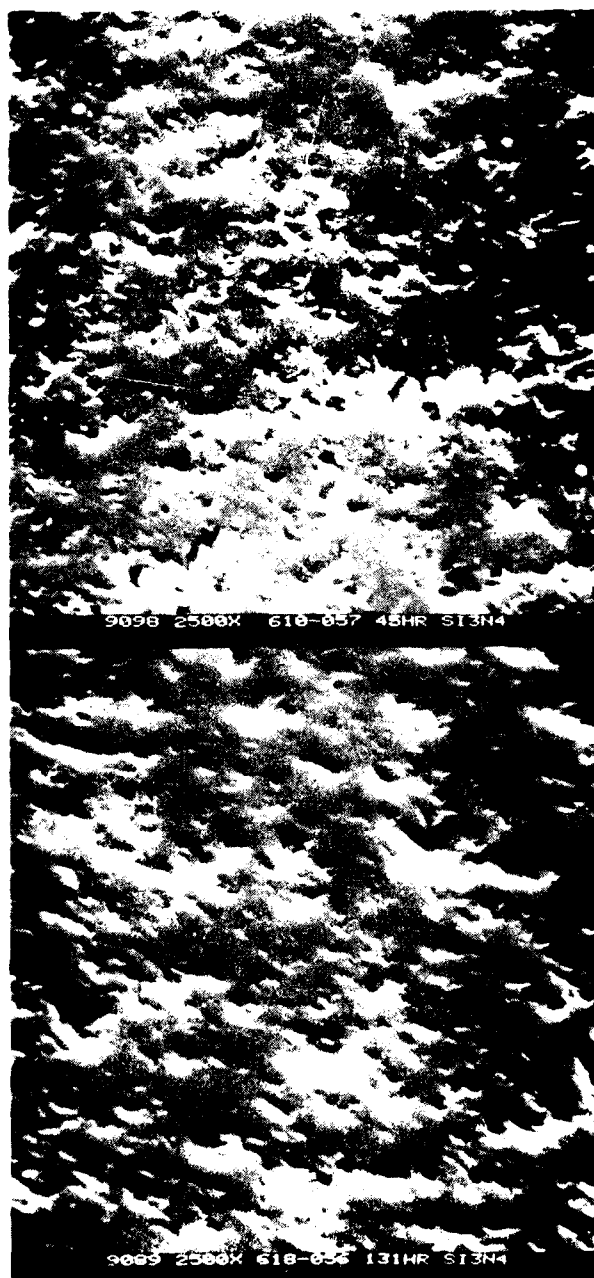
Figure 14. Photomicrographs of Silicon Nitride Ball
 Surface. (a) 1000X Magnification. (b) 2500X
 Magnification. (c) 5000X Magnification.

Figure 14 shows the surfaces of two unfailed silicon nitride balls after 45 and 131 hours (33.1 and 76.2×10^6 revolutions) of testing at the high thrust load level. The general surface appearance of these balls is similar to that of the untested balls shown previously in Figure 5. Figure 15 shows the surfaces of two silicon nitride balls which accumulated more than 700 hours (400×10^6 revolutions) without failure at the low load level. The appearance of these components is also comparable to that of the untested balls.

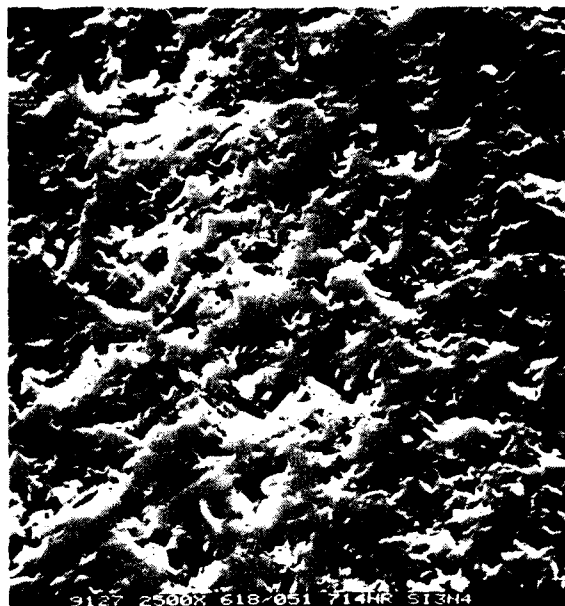
Figure 15. Photomicrographs of Unfailed Silicon Nitride Ball
Surfaces Run Under 100 Load

Balls from Bearing 51
5.0 kN Test Load; 714 Test Hours

The surfaces of unfailed balls appear to be comparable to that of new balls regardless of the amount of running time accumulated. This is true even for those balls taken from bearings having failures. In comparison, the steel raceways of bearings containing a failed element showed extensive amounts of denting and abrasive wear.
